**BloodSTOP IX Hemostatic Matrix for dental usage cases**  
**-from Dr. J. Hill, Utah**

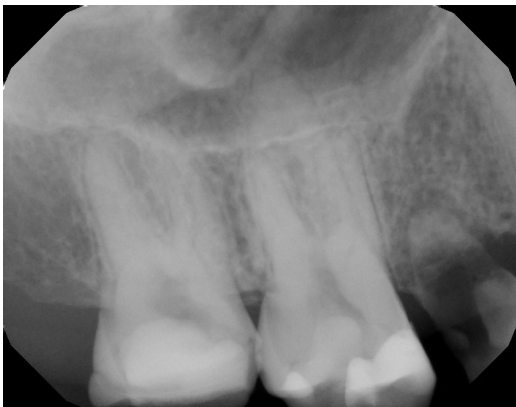
**Patient 2**

Initial problem. Baby tooth retained into adulthood. Now failing.

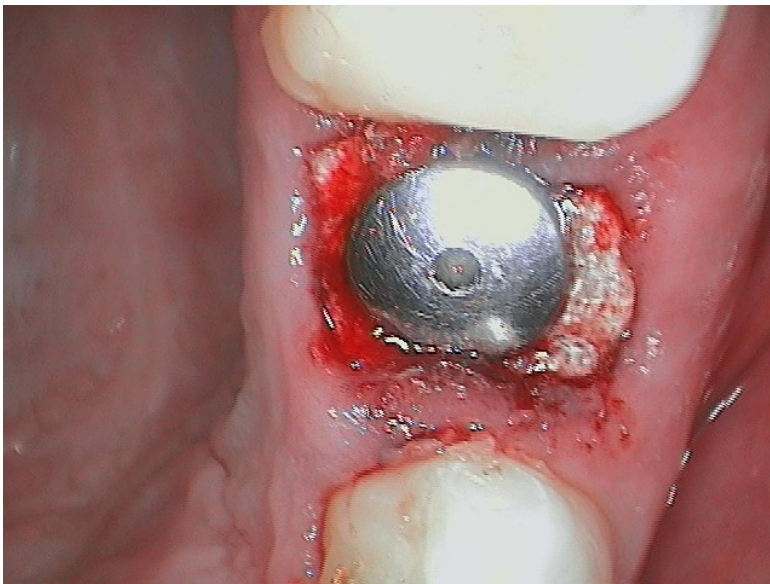
The baby tooth left a wide defect in the soft tissue and the bone, a defect much wider than the implant at the top. The defect was filling with bone graft material and a metal "tissue former" put in place. Then "wads" of BloodStop IX were placed to fill the soft tissue gaps and hold the bone graft granules inside.

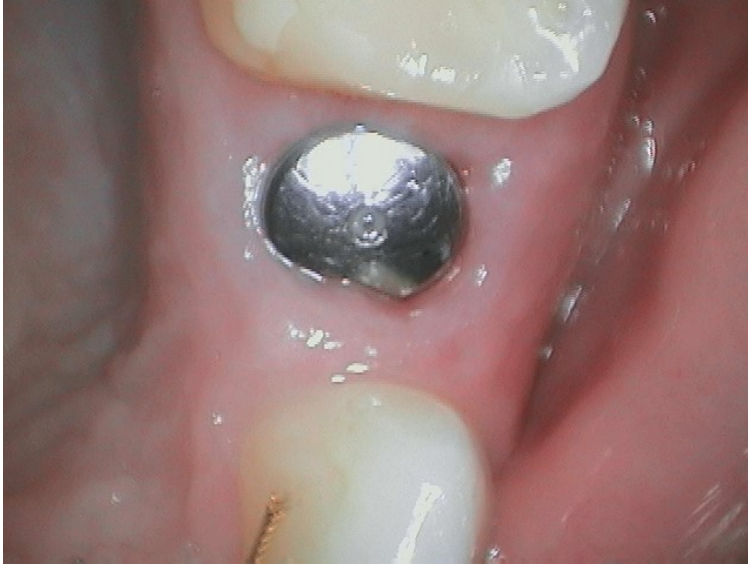
Eleven day healing check.

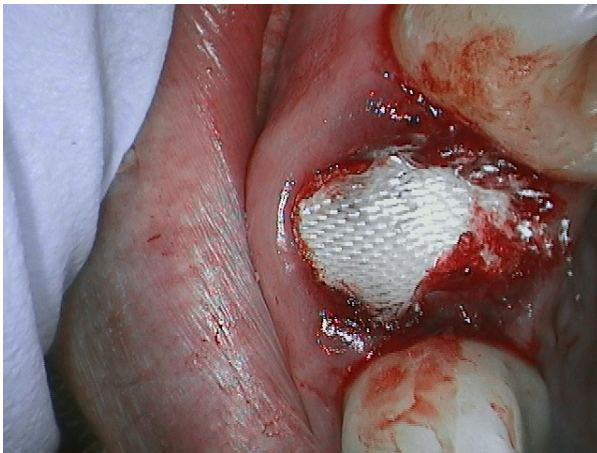
Double layer of BloodStop IX placed to cover site like the "pie crust."

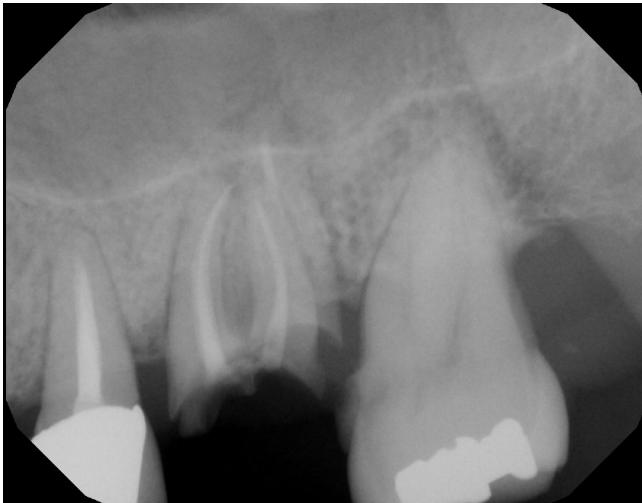
## Patient 4

Initial problem. Tooth broken off at gumline. Infection in bone around tooth. Surgery day we extracted tooth, placed bone graft material and covered it with BloodStop IX with my pie crust technique. Sorry. We have no photo of Surgery day result.

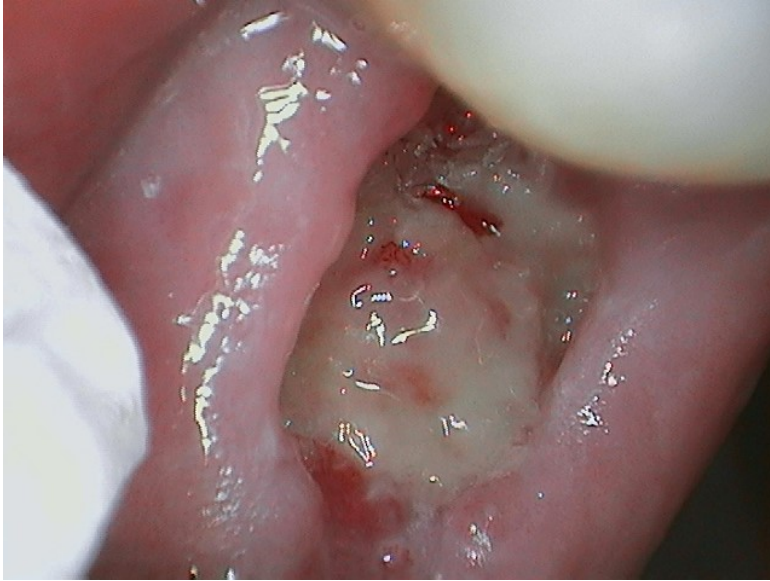
But this photo is the 14 day healing check.

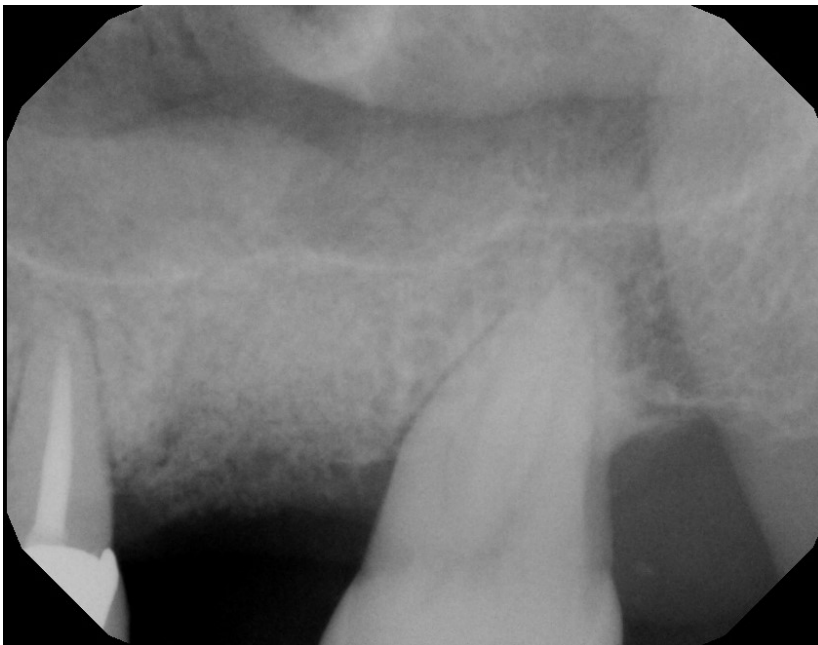
4.5 month bone healing check

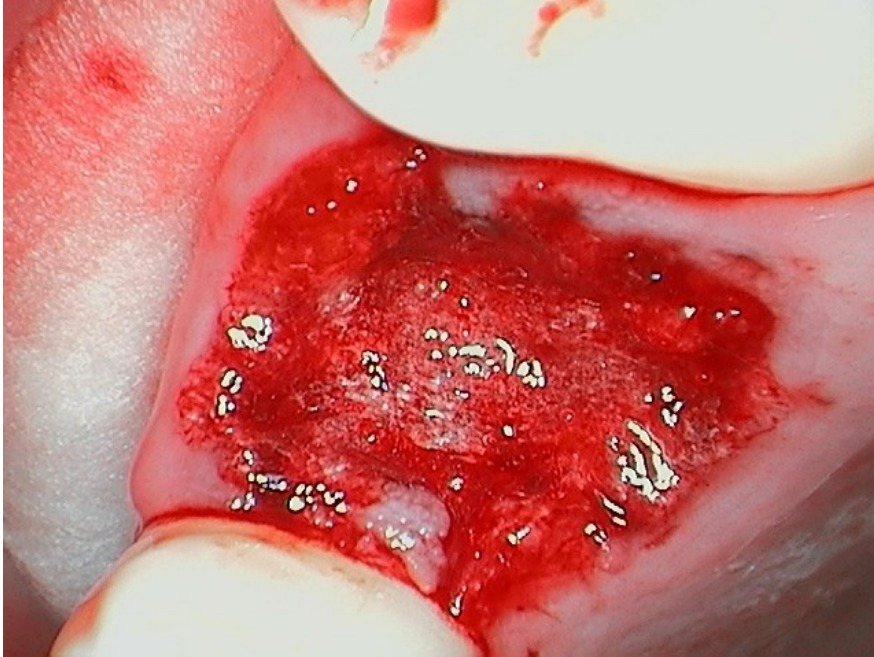
Same site after wetting with water.

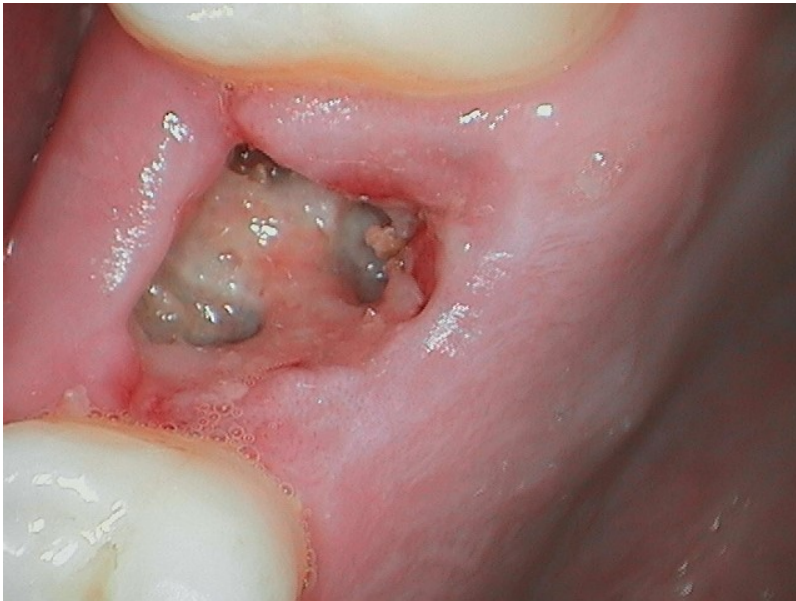
Five day healing. Cover did not hold. Graft failed. But Sinus communication still closed.

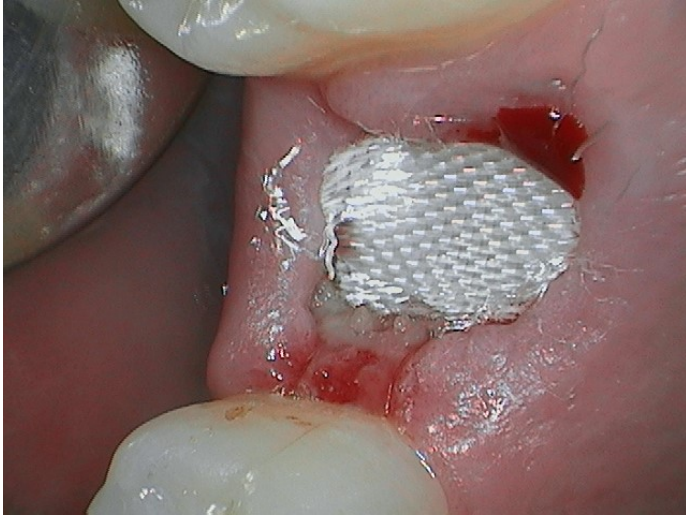
Wads put in each root hole and new pie crust cover placed.
